**Flood Control Project Maintenance
Levee Inspections**

Maintenance Issue Types Only, Levee Inspection Report By Mile - Spring 2017

Reclamation District No. 0501 Ryer Island

| Waterway | Bank | Unit Miles | Inspection Start/End | Inspector |
|---|---|---|---|---|
| Unit No. 01 Steamboat Slough | Right | 6.71 | 04/27/2017 04/27/2017 | Herman Phillips |

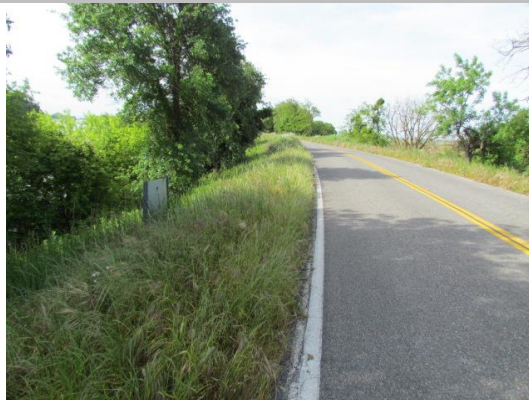
Photo 1 of 1 : SP_2017_RD0501_169_44_20170522_00058.jpg

| Item | Vegetation | | | 38.254035 ° | 38.215490 ° |

RD 501 Unit 1 looking downstream from levee 0.04 waterside.

| Control the annual grasses and weeds from the levee slope. | | | | | |

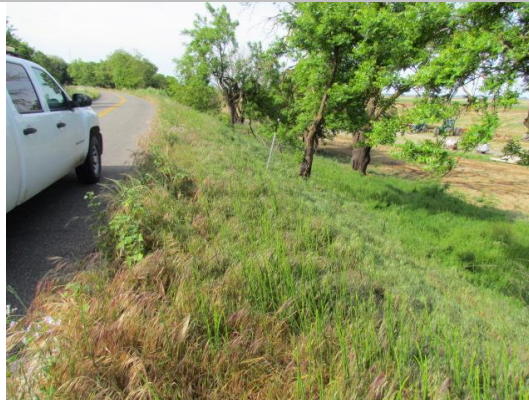
Photo 1 of 1 : SP_2017_RD0501_169_42_20170522_00059.jpg

RD 501 Unit 1 looking downstream from the landside slope.

| Control the annual grasses and weeds from the landside slope. | | | | | |

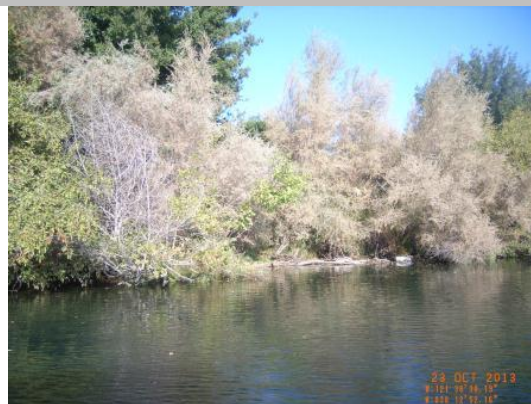
Photo 1 of 1 : SP_2017_RD0501_169_3_20170404_00003.jpg

| 2009 - Rock is starting to unravel, probably from a tree pop-out, hard toe. 2015: No observed changes. [2015 Site ID: STM_18-9_R] | | | | | |

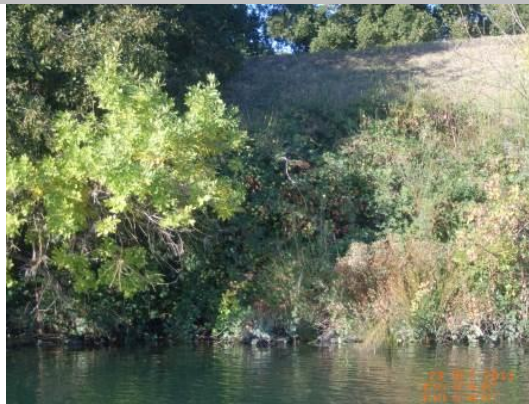
Photo 1 of 1 : SP_2017_RD0501_169_2_20170404_00002.jpg

| 2000 - Slow erosion of lower and mid-slope with rock bench at the low water line. 2015: No observed changes. [2015 Site ID: STM_18-8_R] | | | | | |

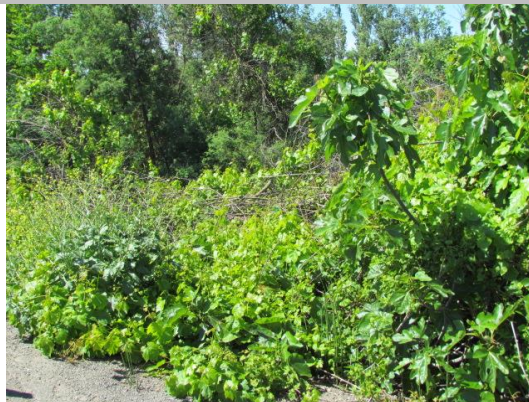
Photo 1 of 1 : SP_2017_RD0501_169_974_20170522_00062.jpg

RD 501 Levee mile 3.73-4.12 wild tree growth and vegetation blocking view of the levee slope.

| Remove the wild growth from the waterside slope. | | | | | |

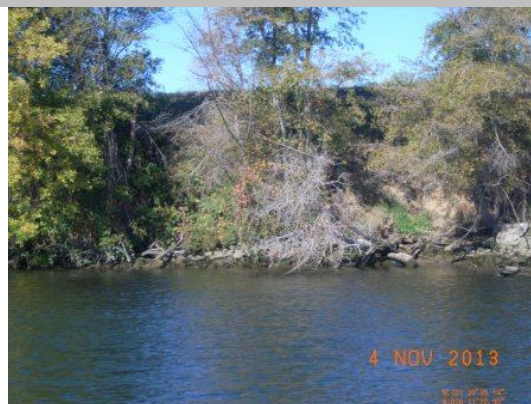
Photo 1 of 1 : SP_2017_RD0501_169_1_20170404_00001.jpg

| 2008 - Overstepped levee section with multiple small pockets of erosion 10 - 20 ft wide. 2013 - Site has fresh erosion and taller vertical sections. 2015: No observed changes. [2015 Site ID: STM_15-7_R] | | | | | |

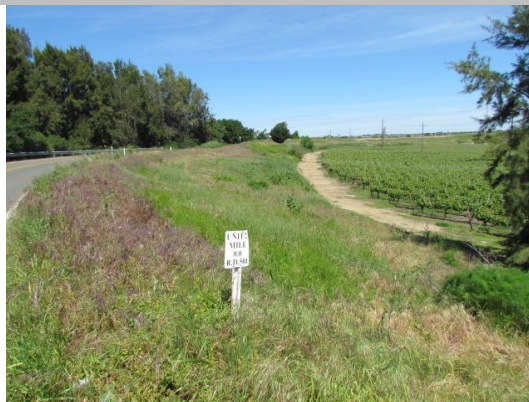
Photo 1 of 1 : SP_2017_RD0501_170_20_20170522_00042.jpg

RD 501 Unit 2 levee mile 0.01-1.09 landside levee slope.

| Control the annual grasses and weeds from the landside slope. | | | | | |

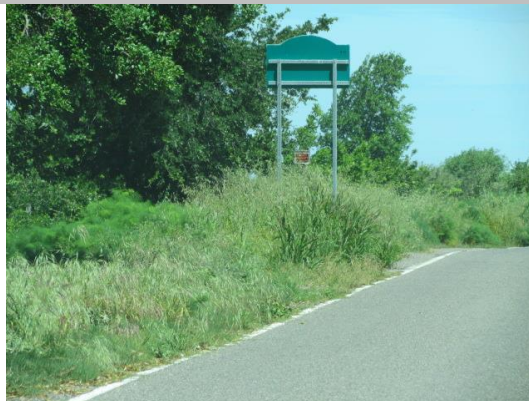
Photo 1 of 1 : SP_2017_RD0501_170_22_20170522_00043.jpg

RD 501 Unit 2 levee mile 0.10-3.55 wateside shoulder and slope.

| Control the annual grasses and weeds on the slope and shoulder. | | | | | |

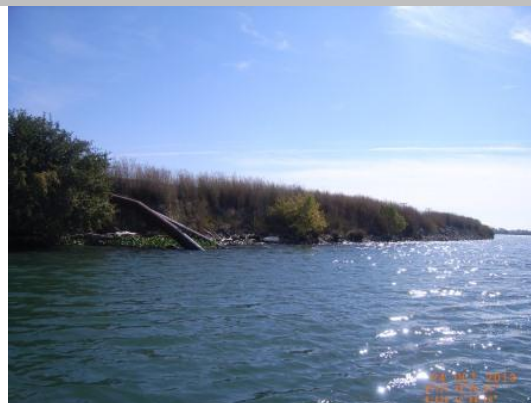
Photo 1 of 1 : SP_2017_RD0501_170_1_20170404_00001.jpg

| 2005 - Large vertical sections due to wave wash. New stone dumped on the bank with exposed geotextile. Cohesive toe has thin weak stratigraphic unit that is washing out. 2006 - Partially repaired, but 100 ft in the middle of the reach has exposed filter fabric and stone riprap is gone. 2010 - Site extended downstream to include new erosion pocket. 2015: No observed changes. [2015 Site ID: CHS 15-9 L] | | | | | |

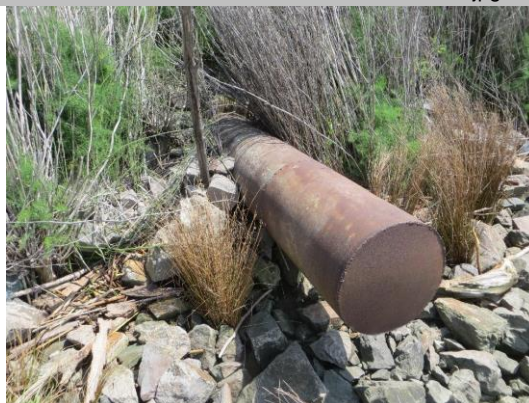
Photo 1 of 3 : UCIP_SP_2017_44753_73955.jpg

| FS_ID:44753 DS_ID:21085 EP_NO: N/A Repair Type: Non-Urgent Crossing Status: Found UCIP Comments: Hole rusted through pipe on WS end. Pipe abandoned and should be done so properly. FIELD_STRUCT_DESC: *ABANDONED* 20-inch steel pipe through the levee, 15.5 feet below the crown. Pipe exposed along waterward slope, Steel plate welded over end (USACE-1959). This entry matches the Drainage or Irrigation Structure referenced in O&M manual (HLM 1.40). FS Date: 4/23/2015 | | | | | |

20-inch pipe with welded steel plate over end on WS toe.

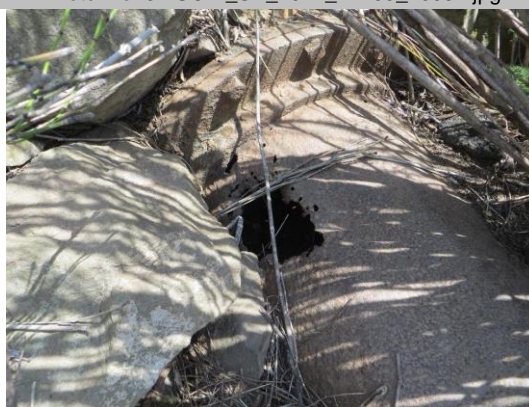
Photo 2 of 3 : UCIP_SP_2017_44753_73954.jpg

Hole in pipe at WS toe.

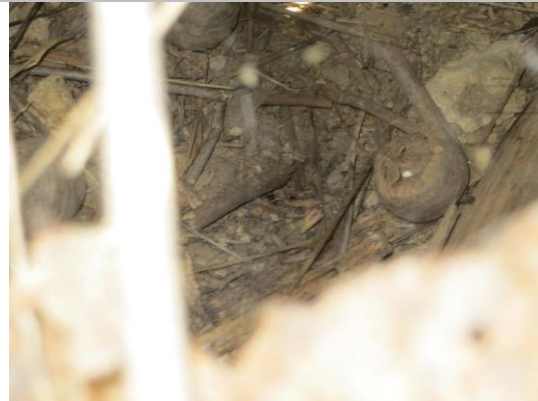
Photo 3 of 3 : UCIP_SP_2017_44753_73953.jpg

| FS_ID:44753 DS_ID:21085 EP_NO: N/A Repair Type: Non-Urgent Crossing Status: Found UCIP Comments: Hole rusted through pipe on WS end. Pipe abandoned and should be done so properly. FIELD_STRUCT_DESC: *ABANDONED* 20-inch steel pipe through the levee, 15.5 feet below the crown. Pipe exposed along waterward slope, Steel plate welded over end (USACE-1959). This entry matches the Drainage or Irrigation Structure referenced in O&M manual (HLM 1.40). FS Date: 4/23/2015 | | | | | |

Inside hole in pipe at WS toe.

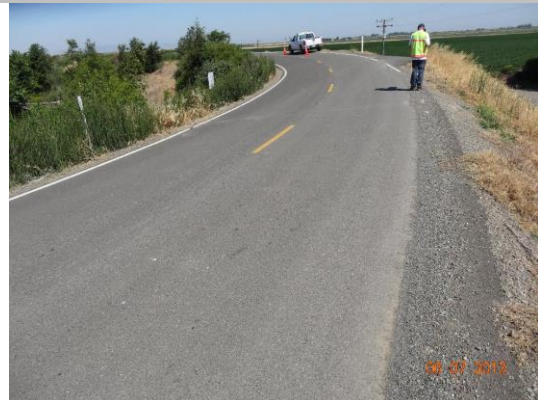
Photo 1 of 3 : UCIP_SP_2017_40489_33358.jpg

| FS_ID:40489 DS_ID:21042 EP_NO: 15477 Repair Type: Non-Urgent Crossing Status: Found UCIP Comments: Stacey Boyd, LMA superintendent for RD0501, confirmed the removal and replacement of existing crossing under new permit no. 18811. New crossing will be a 30-inch diameter discharge pipe above the design flood plane. Construction will start soon. Update record once the project is completed. Dense vegetation on both waterside and landside. Recommend removing vegetation along pipe alignment to conduct proper inspection of structure and appurtenances. FIELD_STRUCT_DESC: 42-inch steel pipe through the levee, 6.5 feet below the crown. Siphon breaker on waterward slope. Pump on the landward side (Permit No. 15477, 1990). Pipe exposed along both slopes. (USACE-1959). This entry matches the Drainage or Irrigation Structure referenced in O&M manual (HLM 2.0). FS Date: 6/7/2013 | | | | | |

Overview of crown, looking downstream.

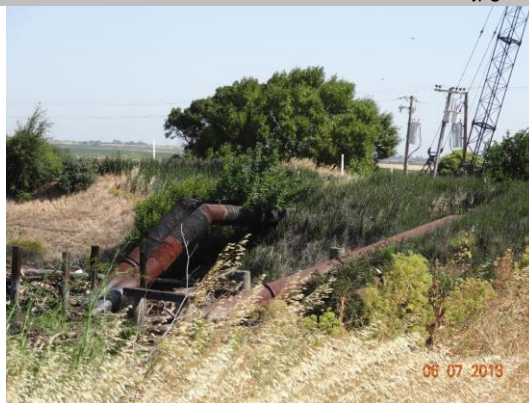
Photo 2 of 3 : UCIP_SP_2017_40489_33359.jpg

One 42-inch steel pile with siphon break on waterside slope.

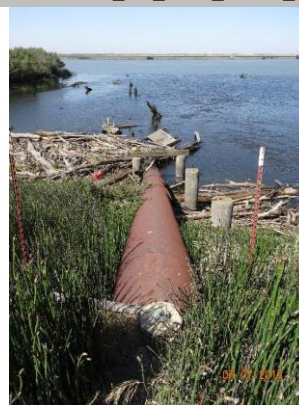
Photo 3 of 3 : UCIP_SP_2017_40489_33357.jpg

Siphon breaker on apex of steel pipe waterside.

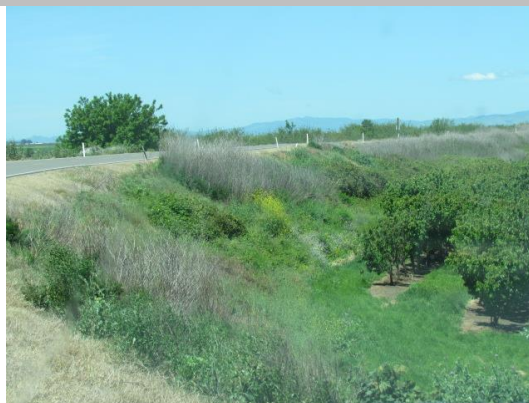
Photo 1 of 1 : SP_2017_RD0501_170_24_20170522_00041.jpg

RD 501 Unit 2 levee mile 1.88-3.55 landside slope.

| Control the annual grasses and weeds on the landside slope. | | | | | |

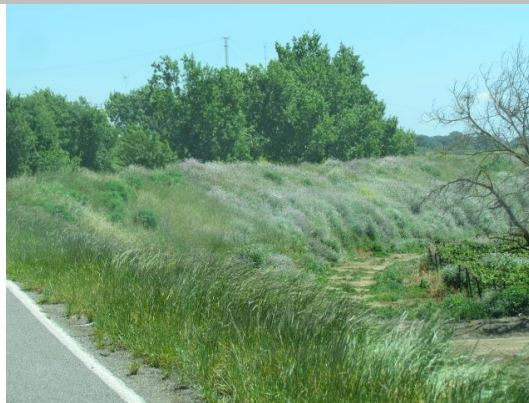
Photo 1 of 1 : SP_2017_RD0501_171_28_20170522_00070.jpg

RD 501 Unit 3 landside shoulder and slope downstream from levee mile 0.00.

| Control annual grasses and weeds on the levee slope and toe. | | | | | |

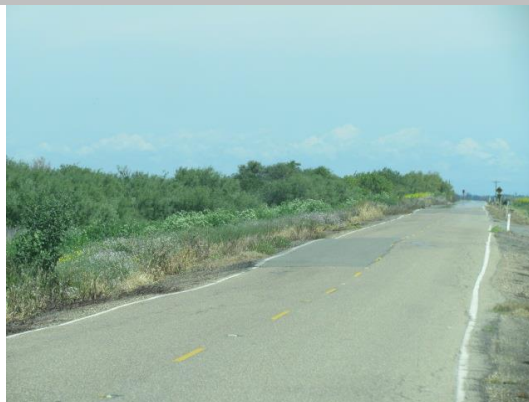
Photo 1 of 1 : SP_2017_RD0501_171_29_20170522_00069.jpg

| Looking downstream from the waterside slope levee mile 0.51 to 7.71 the weeds and annual grasses should be controlled from the waterside slope and toe. | | | | | |

RD 501 Unit 3 From levee mile 0.00-7.71 waterside slope.

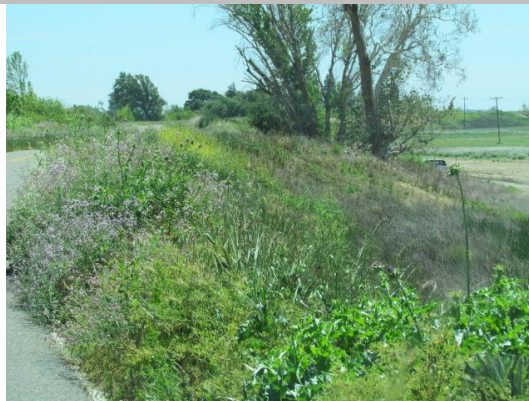
Photo 1 of 1 : SP_2017_RD0501_172_11_20170522_00029.jpg

RD 501 Unit 4 levee mile 0.04 landside slope and shoulder.

| Control the annual grasses and weeds on the levee shoulder and slope. | | | | | |

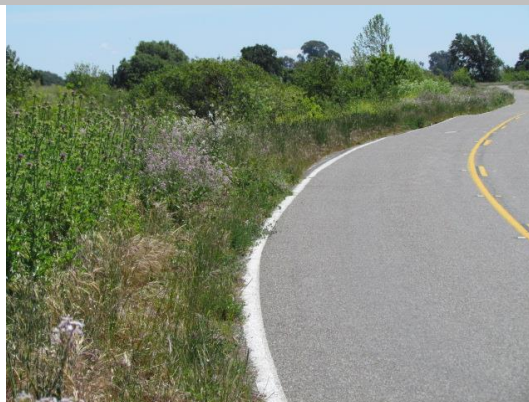
Photo 1 of 1 : SP_2017_RD0501_172_12_20170522_00030.jpg

RD 501 Unit 4 levee mile 0.04 to levee mile 2.28 waterside shoulder and slope.

| Control the annual grasses and weeds from the shoulder and slope water ward. | | | | | |

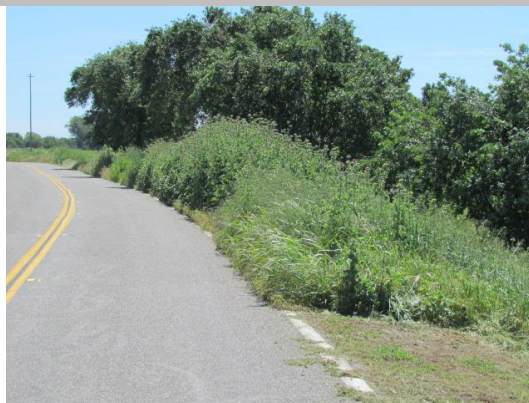
Photo 1 of 1 : SP_2017_RD0501_172_14_20170522_00031.jpg

RD 501 Unit 4 levee mile 1.21 to 2.17 landside shoulder and slope.

| Control the annual grasses and weeds from levee mile 1.21 to levee mile 2.17. | | | | | |
